AUSTRALIAN PARACHUTE FEDERATION

RISER FAILURE

MANDATORY INSPECTION in accordance with APF Service Bulletin **APF010801-B* Issued 23rd January 2009** of **all 3-ring riser assemblies before the next jump**. Inspection to be noted on reserve packing card and marked on inside of front riser with APF010801-B using a fine tip paint pen so it will be visible even if the risers are black.

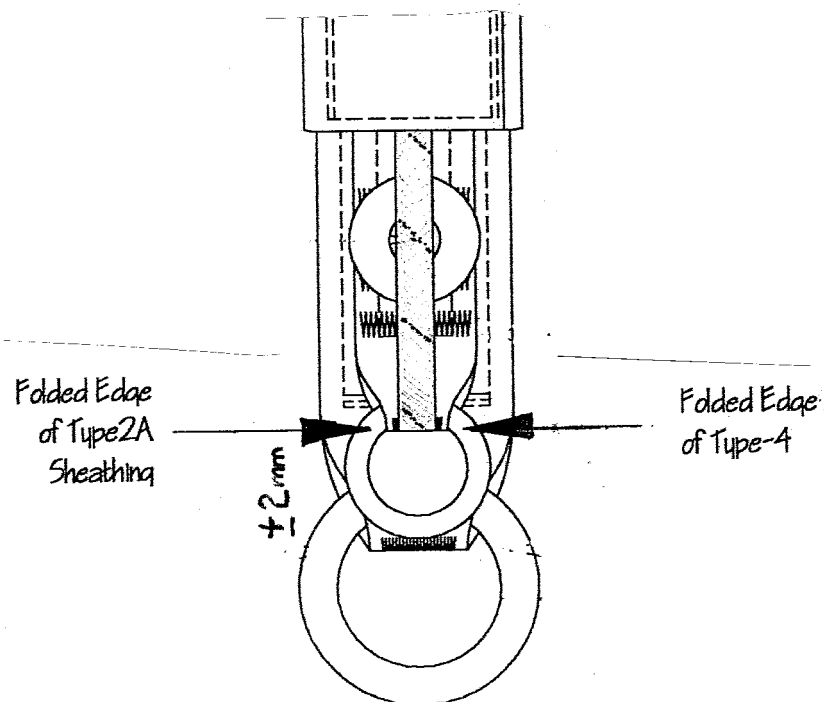
On all solo rigs and all types of riser style, one inch type 17 mini rings, type 8 mini rings and standard type 8 with the larger rings, the length of the locking loop should be level (+/- 2mm) with the end of the fold of the webbing that retains the small ring when the riser is laid flat with some tension applied to the small ring.

It is normal for new type 17 mini risers to be tight to interlock the rings, this is because they become more pliable with use, but the locking loop must still allow the housing some play and not pull the small ring against the riser, see side view on service bulletin.

Typical view of locking loop length
